**NOTIFICATION FORM FOR THE NOTIFICATION OF DANGEROUS PRODUCTS
TO THE AUTHORITIES BY PRODUCERS OR DISTRIBUTORS**

Recall Campaign

Reference Number: CL-959220-N212
14th February, 2023

SUBJECT : NQR90 seatbelt warning light does not illuminate

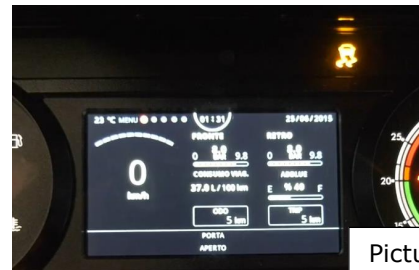
Picture 1

Isuzu found that seatbelt warning does not illuminated when the passenger sits in the seat in assembly line in Turkey.

Improper cab harness design by vehicle manufacturer.

Picture 1. Not correct condition: the Seat Belt Warning Light remains OFF despite the seat is occupied and the seat belt is not fastened.

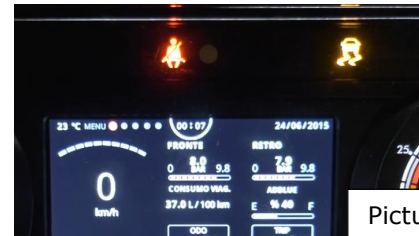
Picture 2

Picture 2. Correct condition (after repair): the Seat Belt Warning Light is ON when the seat is occupied and the seat belt is not fastened.

Cab harness circuit modification.
