**NOTIFICATION FORM FOR THE NOTIFICATION OF DANGEROUS PRODUCTS
TO THE AUTHORITIES BY PRODUCERS OR DISTRIBUTORS**

Recall Campaign

Reference Number: CL-959220-N212
14th February, 2023

SUBJECT : NQR90 seatbelt warning light does not illuminate

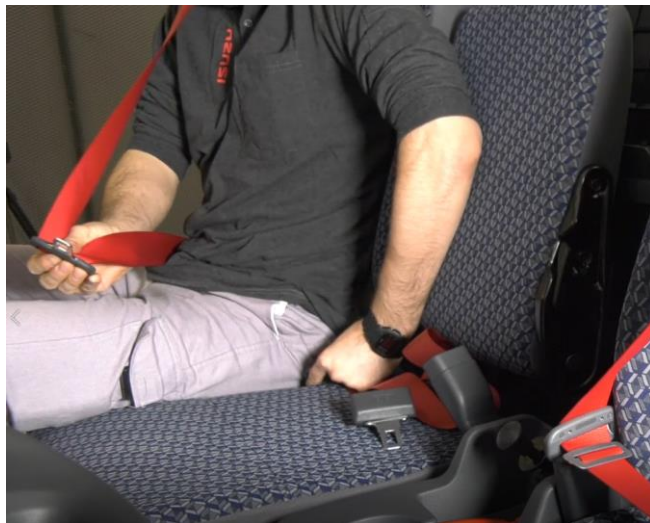
No Good condition

Confirm that the Seat Belt Warning Light illuminates when one or both passenger seats are occupied (with seat belts not fastened).

If the Seat Belt Warning Light does not illuminate, proceed to step C.

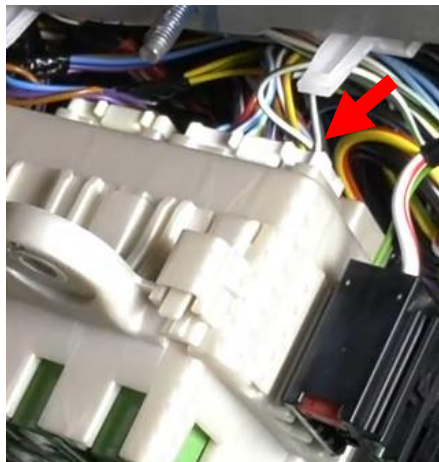
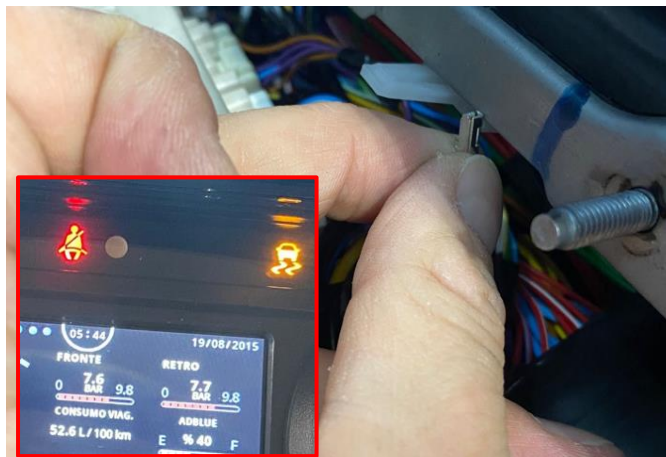
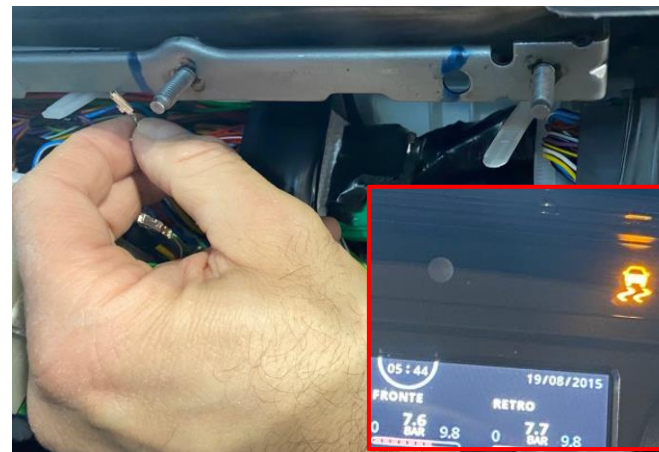
Warning light ON = Wire 1

Warning light OFF = Wire 2

- 1) Reinsert connector B18 (with the white/green wires removed) in the relay and fuse box. This operation is recommended in order not to generate error codes after switching ON the ignition.
- 2) Switch ON the ignition.
- 3) Touch each terminal of the two previously prepared white/green wires to a ground point on the vehicle. In the example photos the Relay and Fuse box support plate is touched.
